# Home Inspection Report

*Report # 1000*

*12345 Memory Lane*

*The inspection was completed on: Wednesday, January 1, 2020*

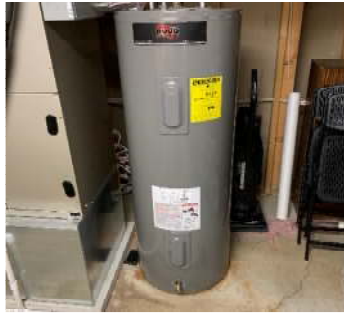
Water Heater

- Relief valve extension is too short; recommend terminate within 6" of floor.

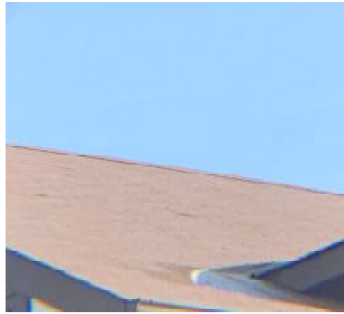
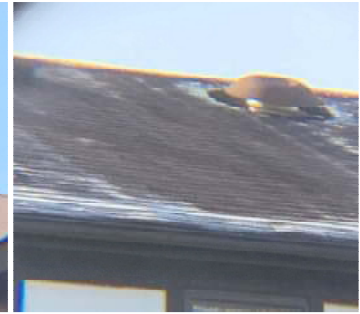
Roof

Based on the age and condition of the roof and roofing materials, it has an estimated 3-5 years of useful life remaining.

- Nail pops, curled edges, and a loose shingle
- Recommend roofer evaluate and repair as needed.

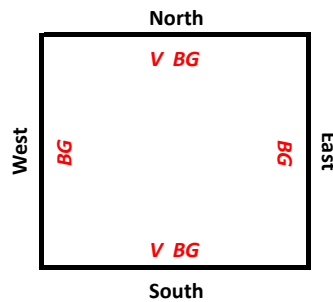
Typical crack (South)

Typical stress cracks on North and South walls.

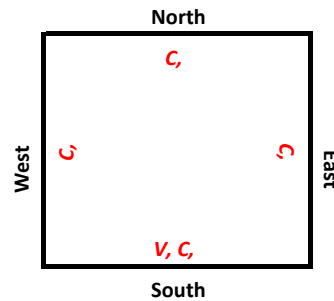
Typical floor cracks
