Home Inspection Report

Report #1111

**John and Jane D.
123 Alpha Street
Somewhere, KY 11115**

February 22, 2013

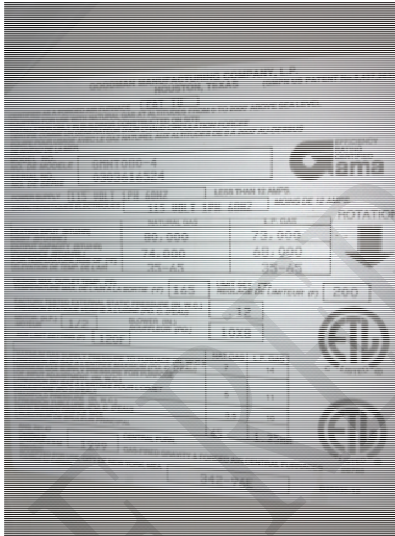
Picture of Tag:

Condition: Marginal

Type: Natural Gas

Age: 14

- Based on the age and style of the furnace it has a normal life expectancy of about 5 – 7 more years

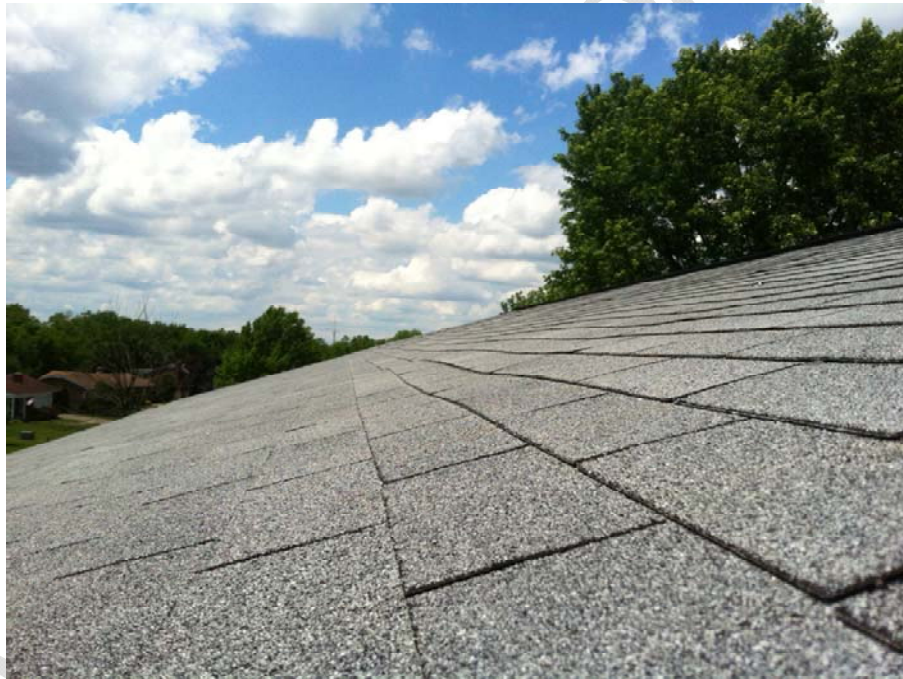
Pictures:

Condition: Poor

- The roof is approximately 12 years old, but appears to have been installed improperly. There are prior repairs noted to patch nail holes in shingles as well as evidence of waviness in the roof. It is recommended to have a roofer evaluate to determine the extent of the repairs or replacement.
